## The Damage Prevention Partnering Process

BY WAYNE JENSEN, DAVID WIRTH AND HOYT LOWDER

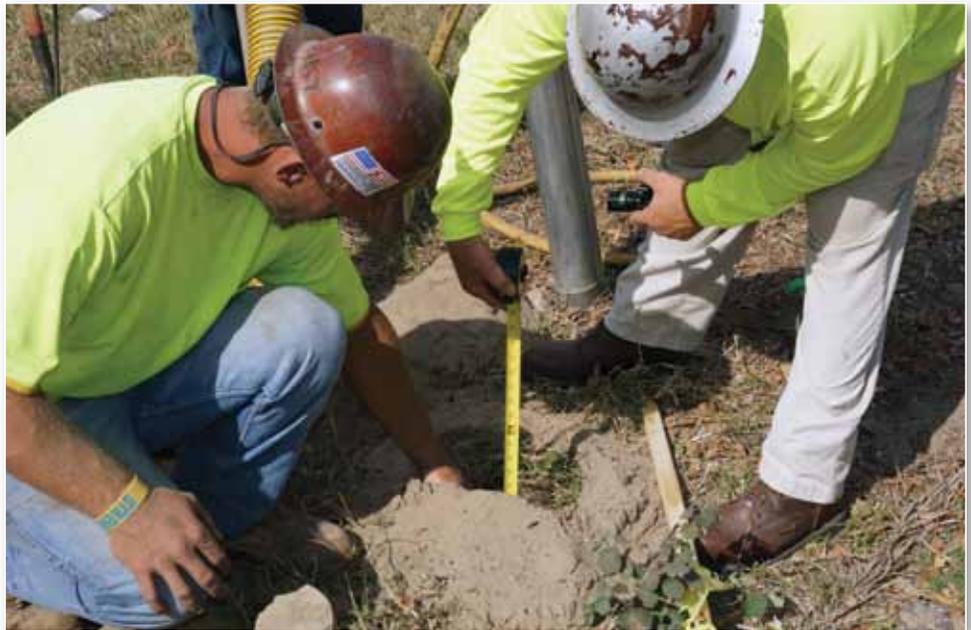
Measuring the depth of a verified utility.

In each case that a facility was exposed using the air knife and vacuum, all parties were able to document depth. On this project, cross-bores with all facilities will not be damaged because of the time spent in this effort.

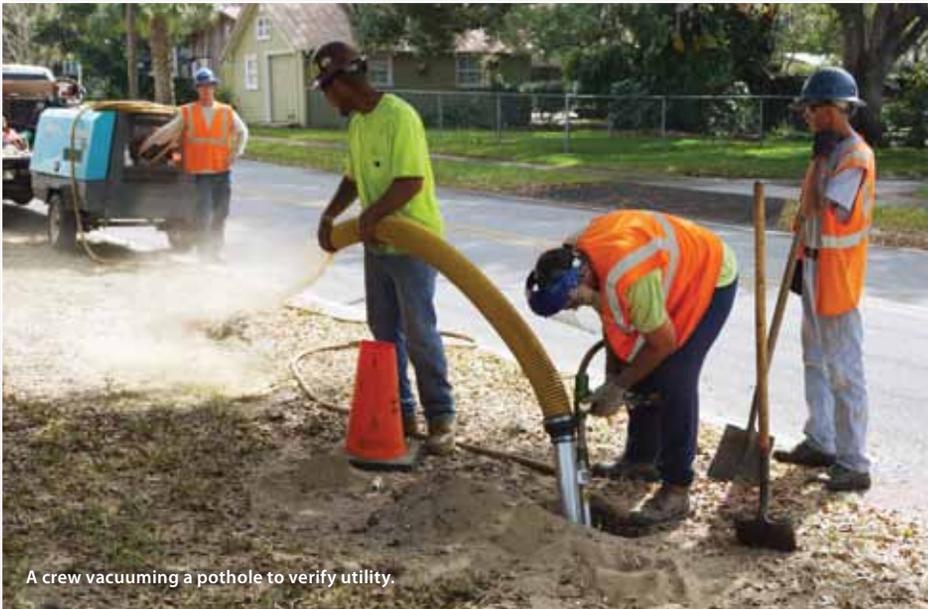
A crew vacuuming a pothole to verify utility.

– Again, in each case, the Dallas 1 crew used the air knife and vacuum to physically uncover each facility.
